Fire safety of existing structures

Retrofit projects

Eoin O'Loughlin | Arup

Structures in Fire Forum (StiFF) | Liverpool | 10 May 2024

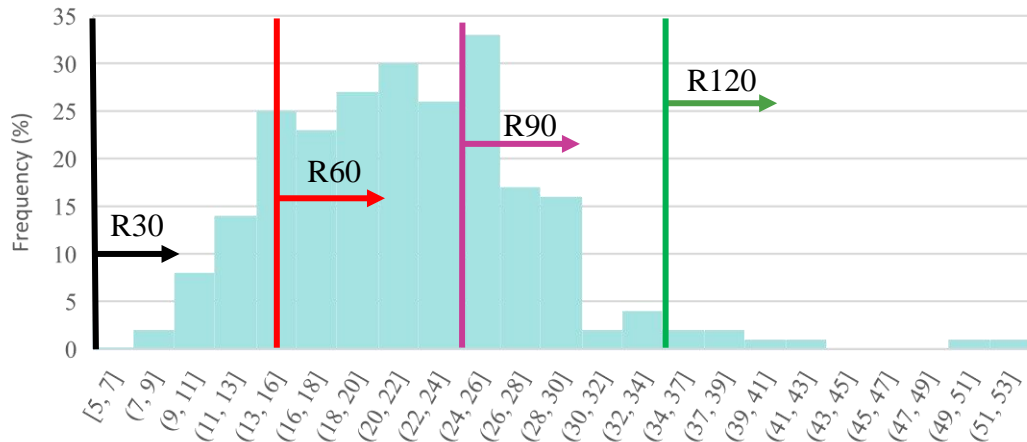
Frequency distribution of concrete cover depth to reinforcement on **first floor** slabs (mm)

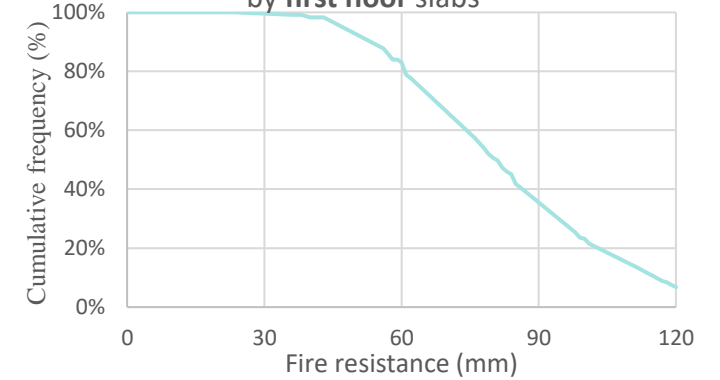
Cumulative frequency of fire resistance by **first floor** slabs

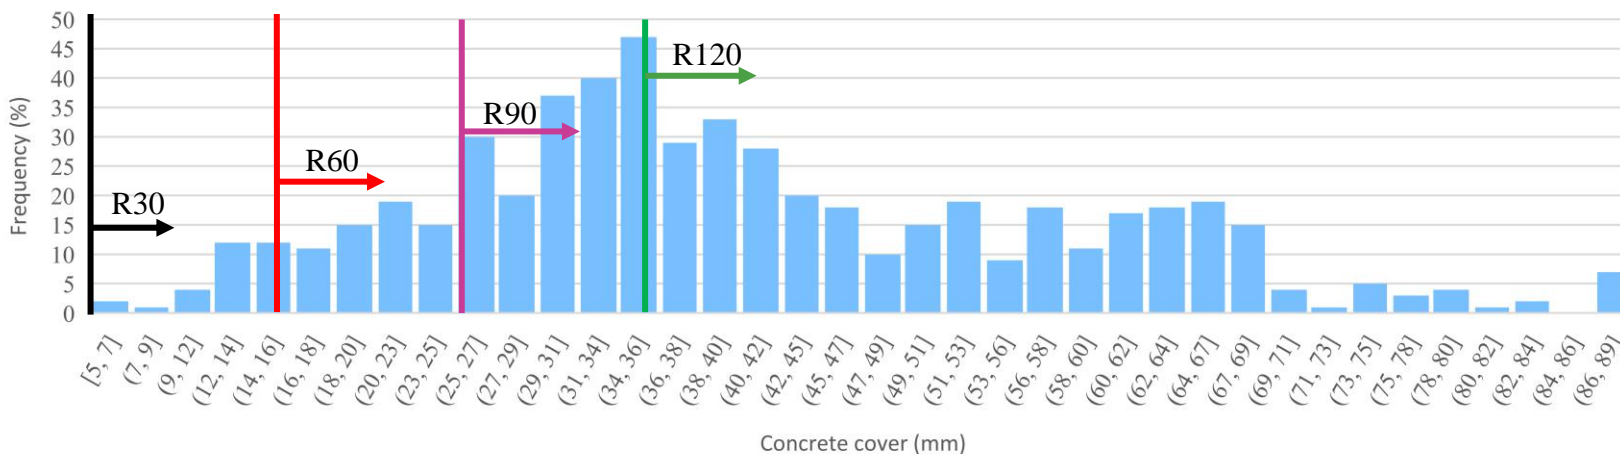
Frequency distribution of concrete cover depth to reinforcement on **third floor** slabs (mm)

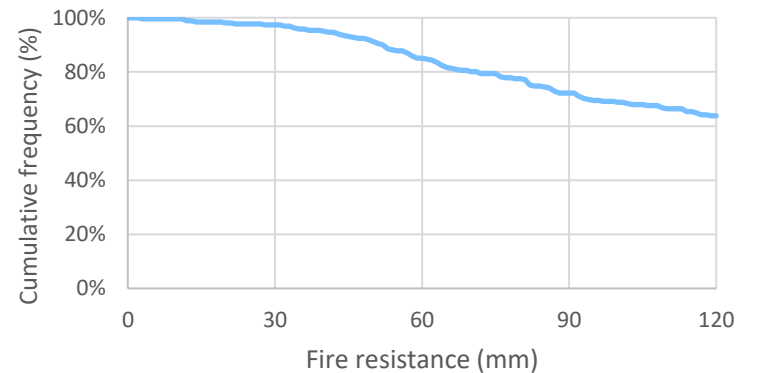
Cumulative frequency of fire resistance by **third floor** slabs

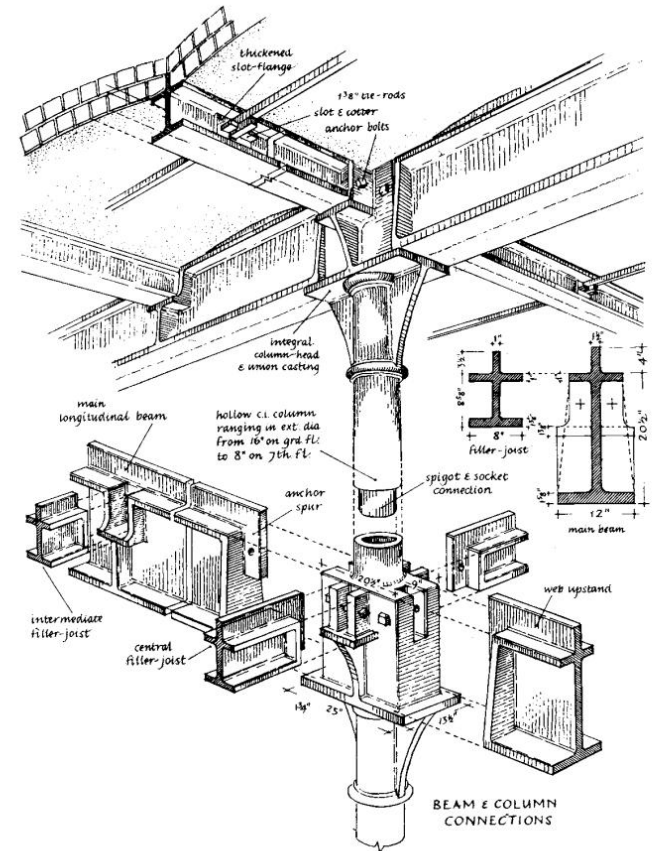
Figure 3.6 Typical early 19th century cast iron frames (reproduced from M...)

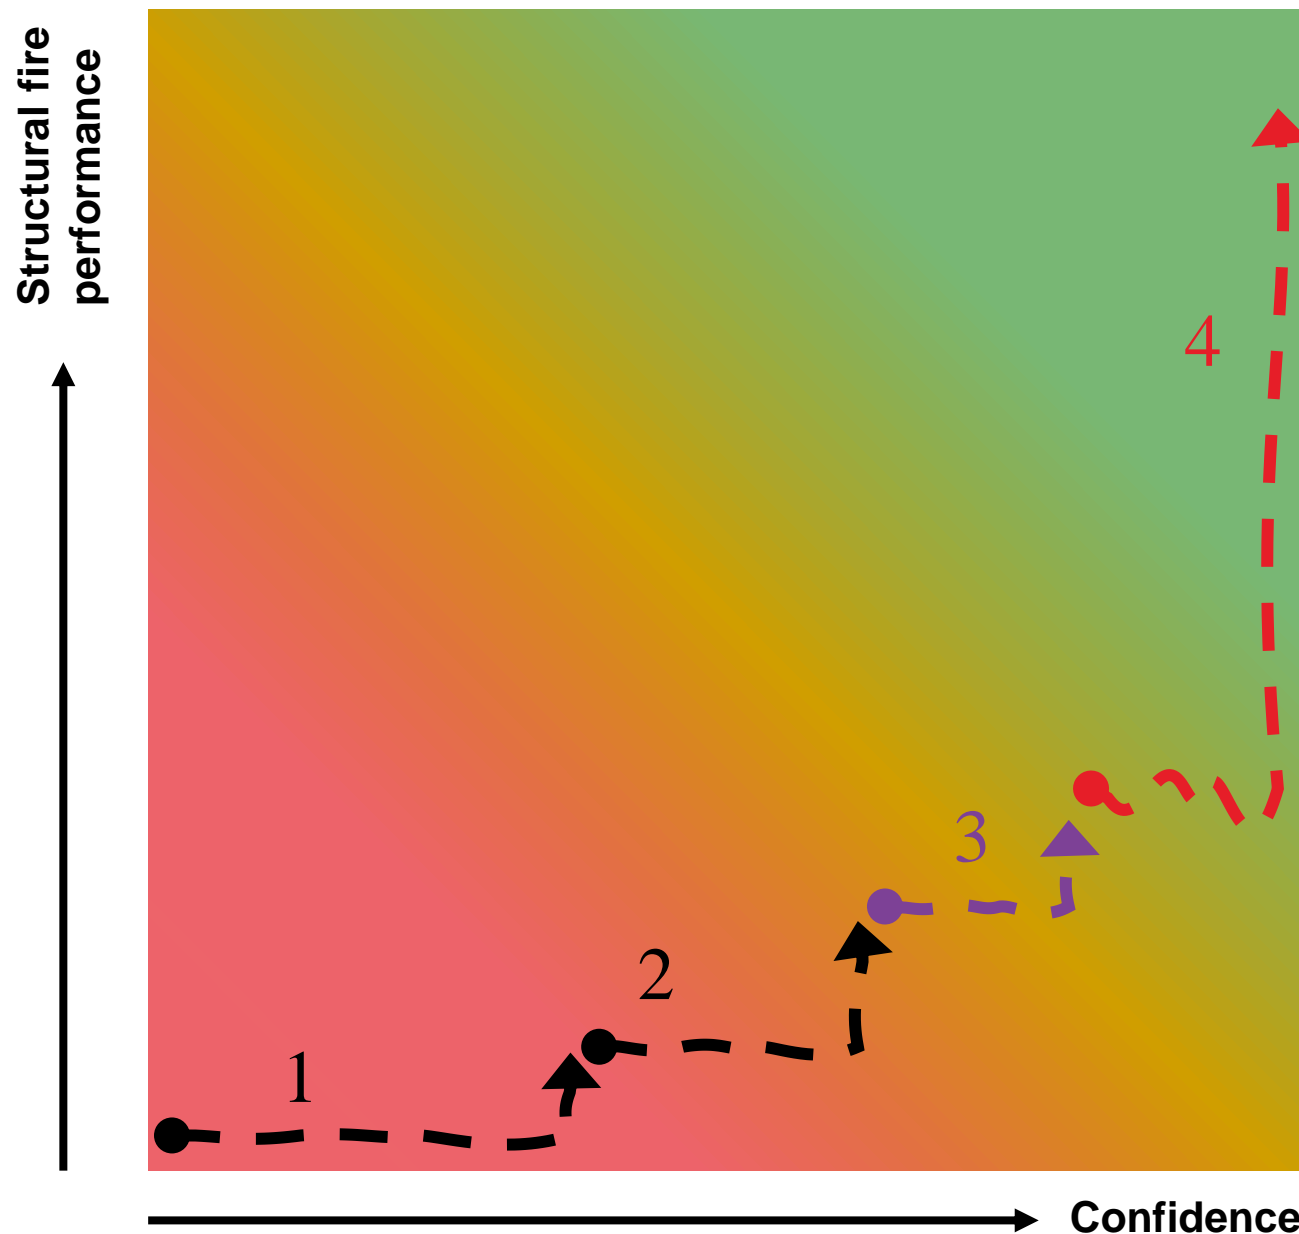
1. Understanding – identify floor type
2. Understanding – pilot survey
3. Assessing – assessment of survey data
4. Evidencing – full remediation

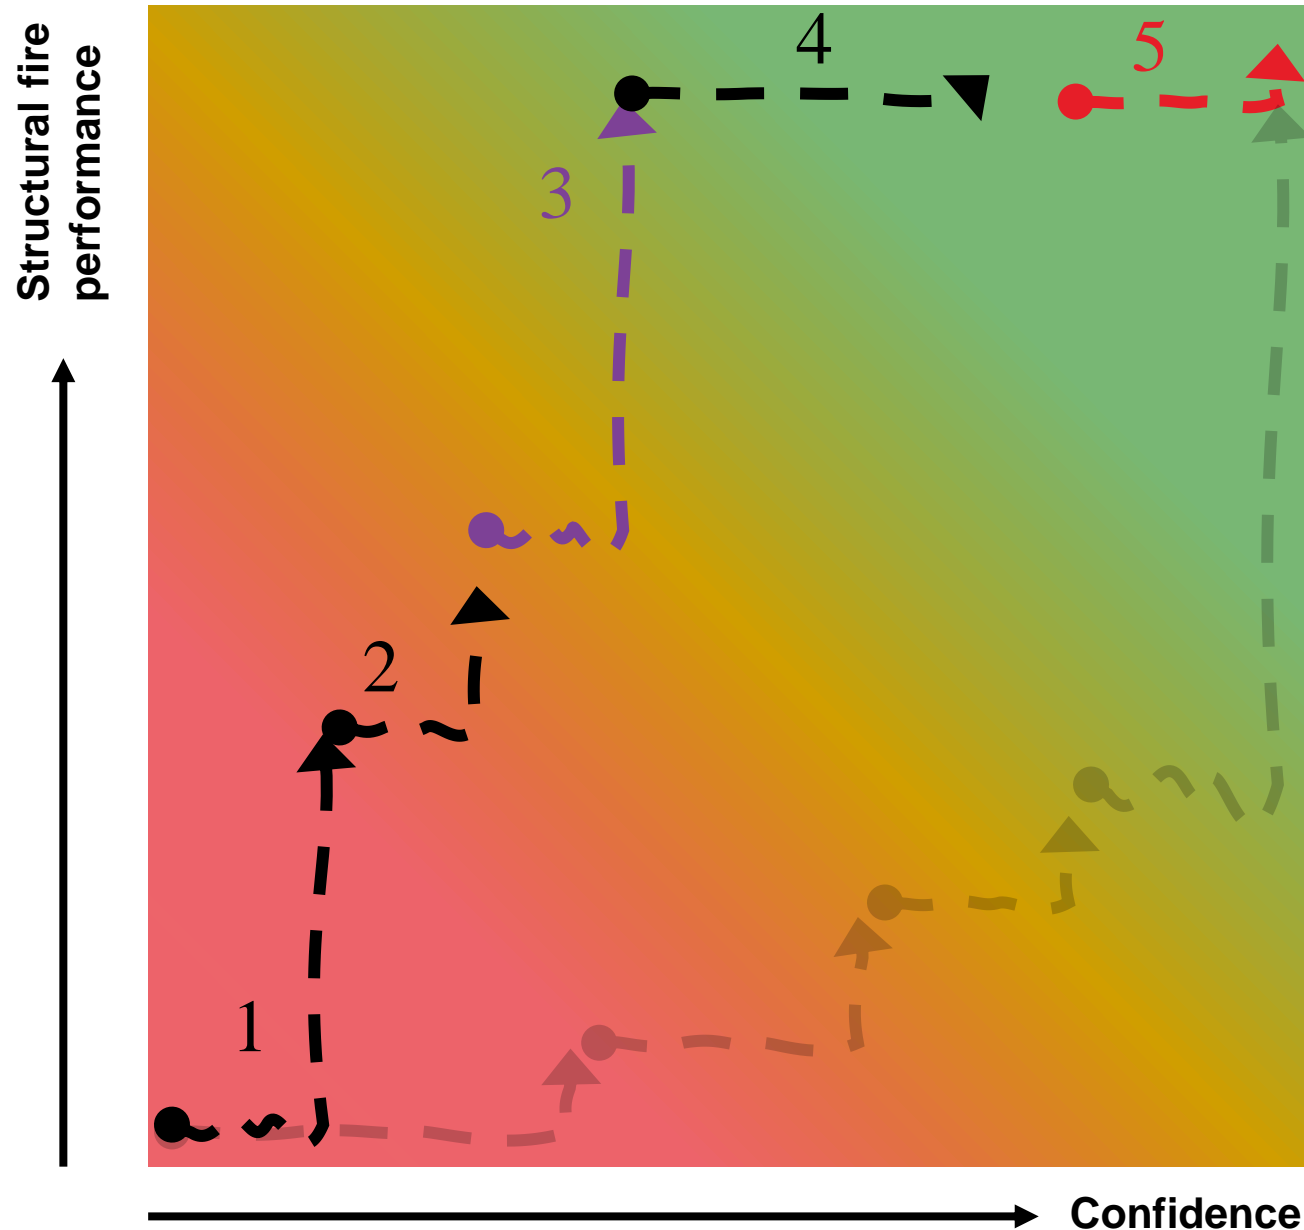
1. Understanding – identify floor type
2. Understanding – pilot survey
3. Assessing – assessment of survey data
4. Understanding – full building survey
5. Evidencing – assessment shows adequate fire resistance

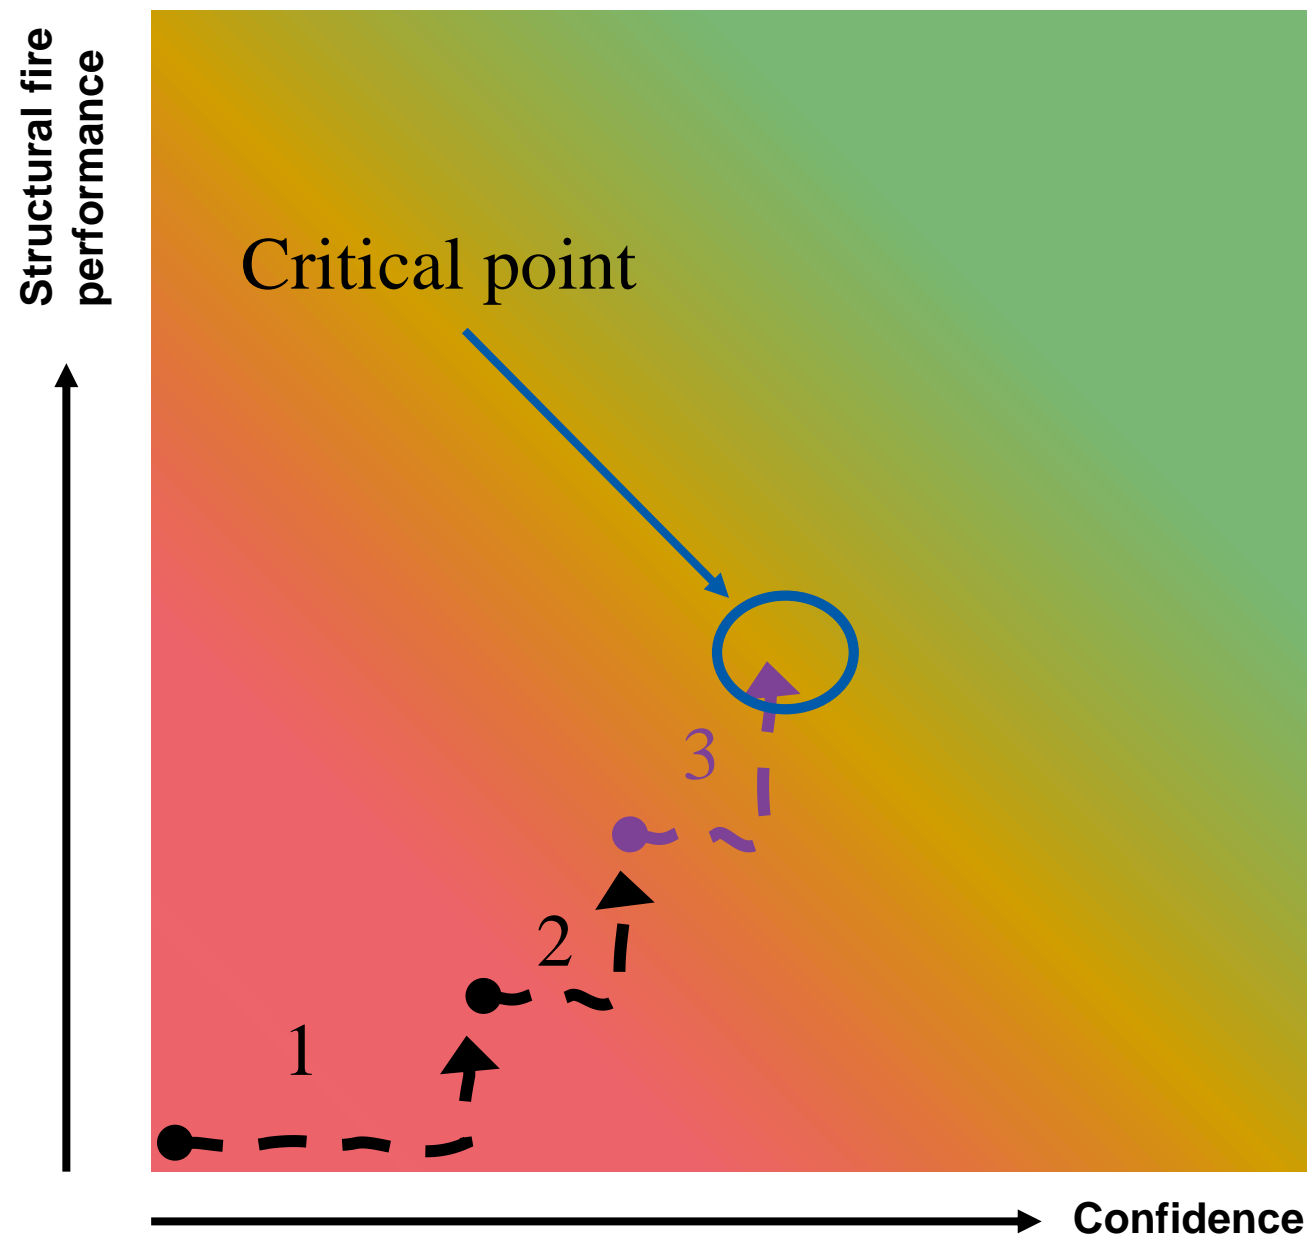
1. Understanding – identify floor type
2. Understanding – pilot survey
3. Assessing – assessment of survey data

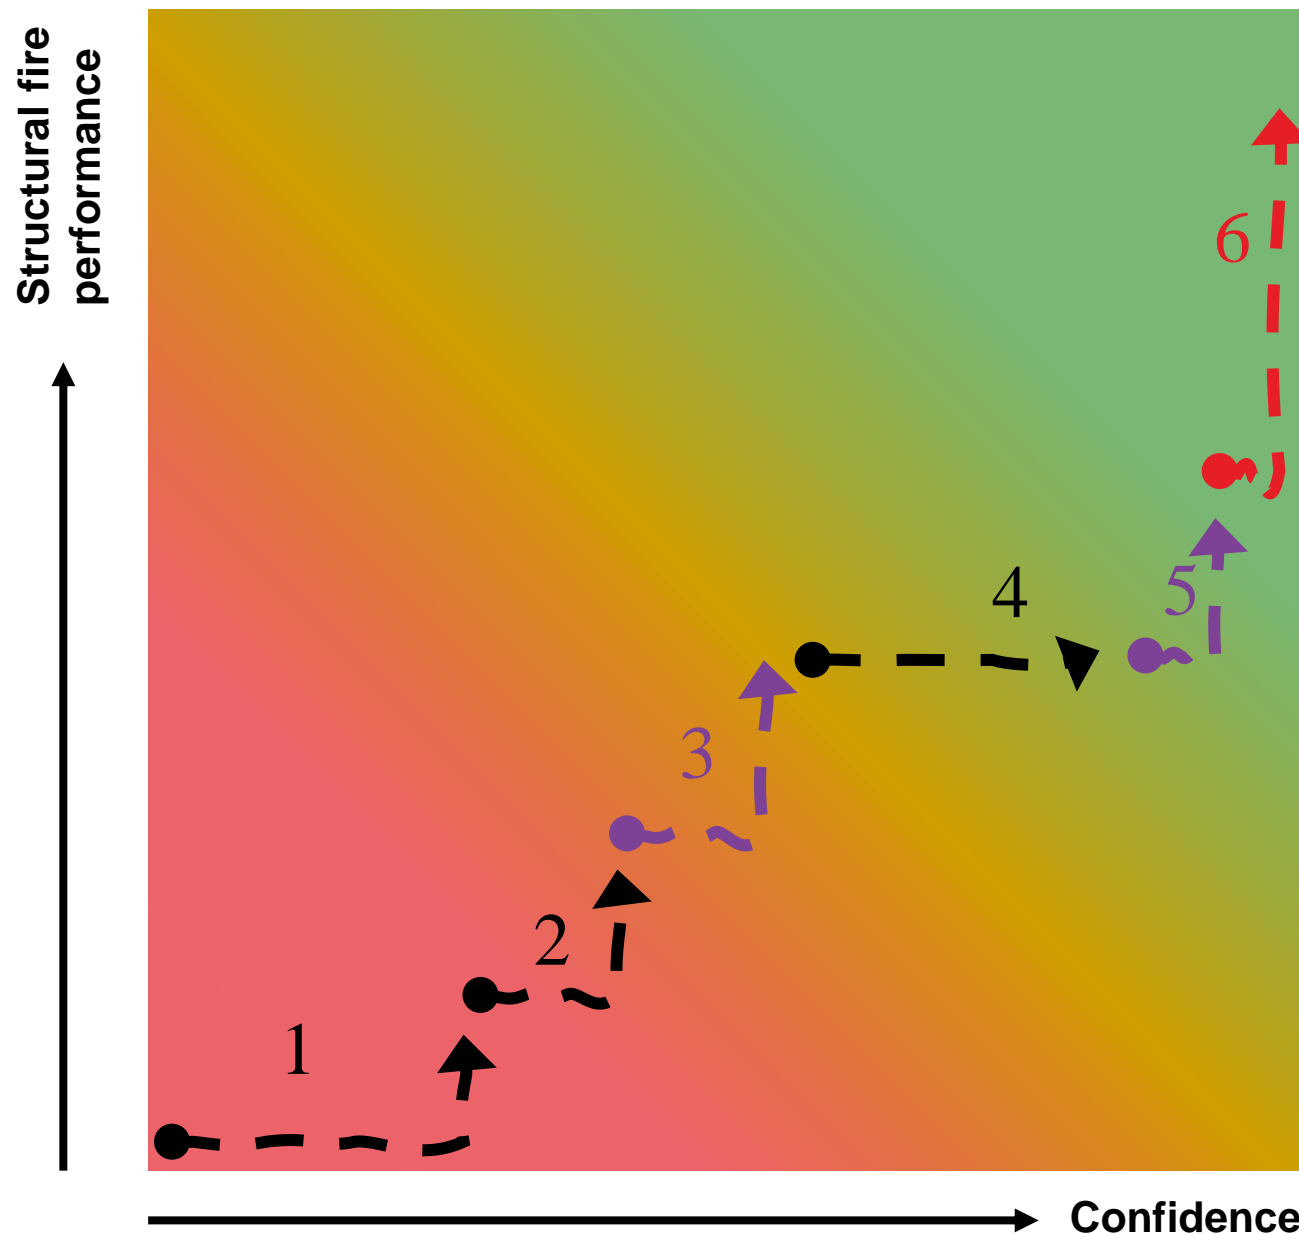
1. Understanding – identify floor type
2. Understanding – pilot survey
3. Assessing – assessment of survey data
4. Understanding – full building survey
5. Assessing – assessment of survey data
6. Evidencing – full remediation

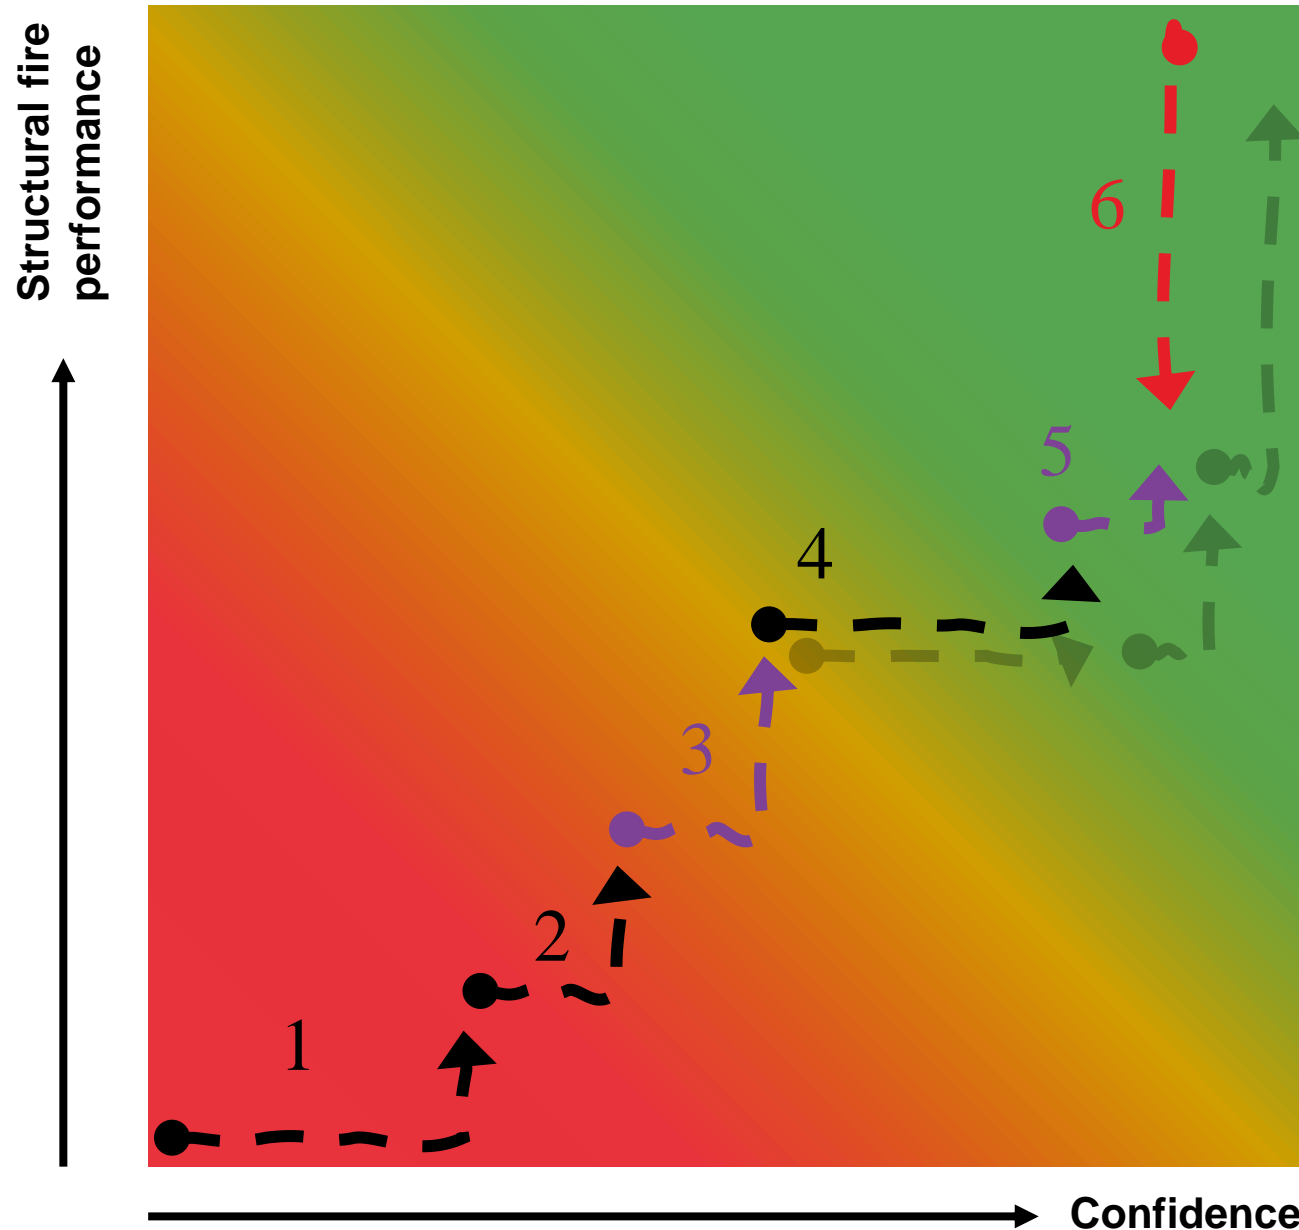
1. Understanding – identify floor type
2. Understanding – pilot survey
3. Assessing – assessment of survey data
4. Understanding – full building survey
5. Assessing – assessment of survey data
6. Evidencing – adjustment to fire strategy lowering the required fire resistance

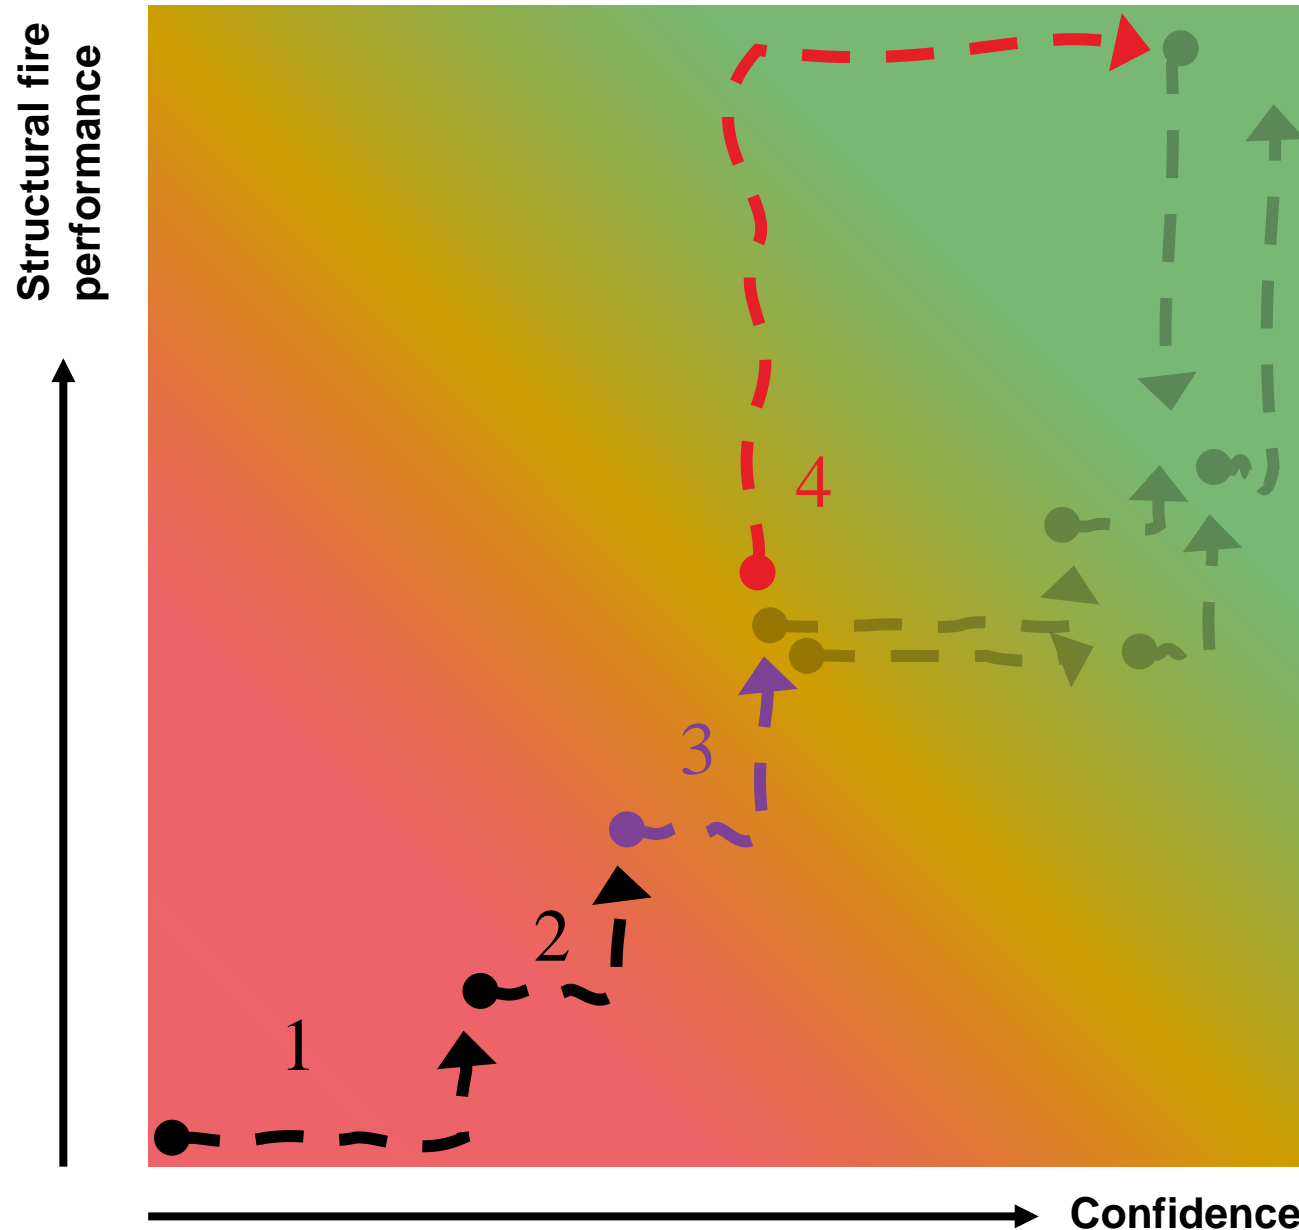
1. Understanding – identify floor type
2. Understanding – pilot survey
3. Assessing – assessment of survey data
4. Evidencing – performance based fire & structural analysis

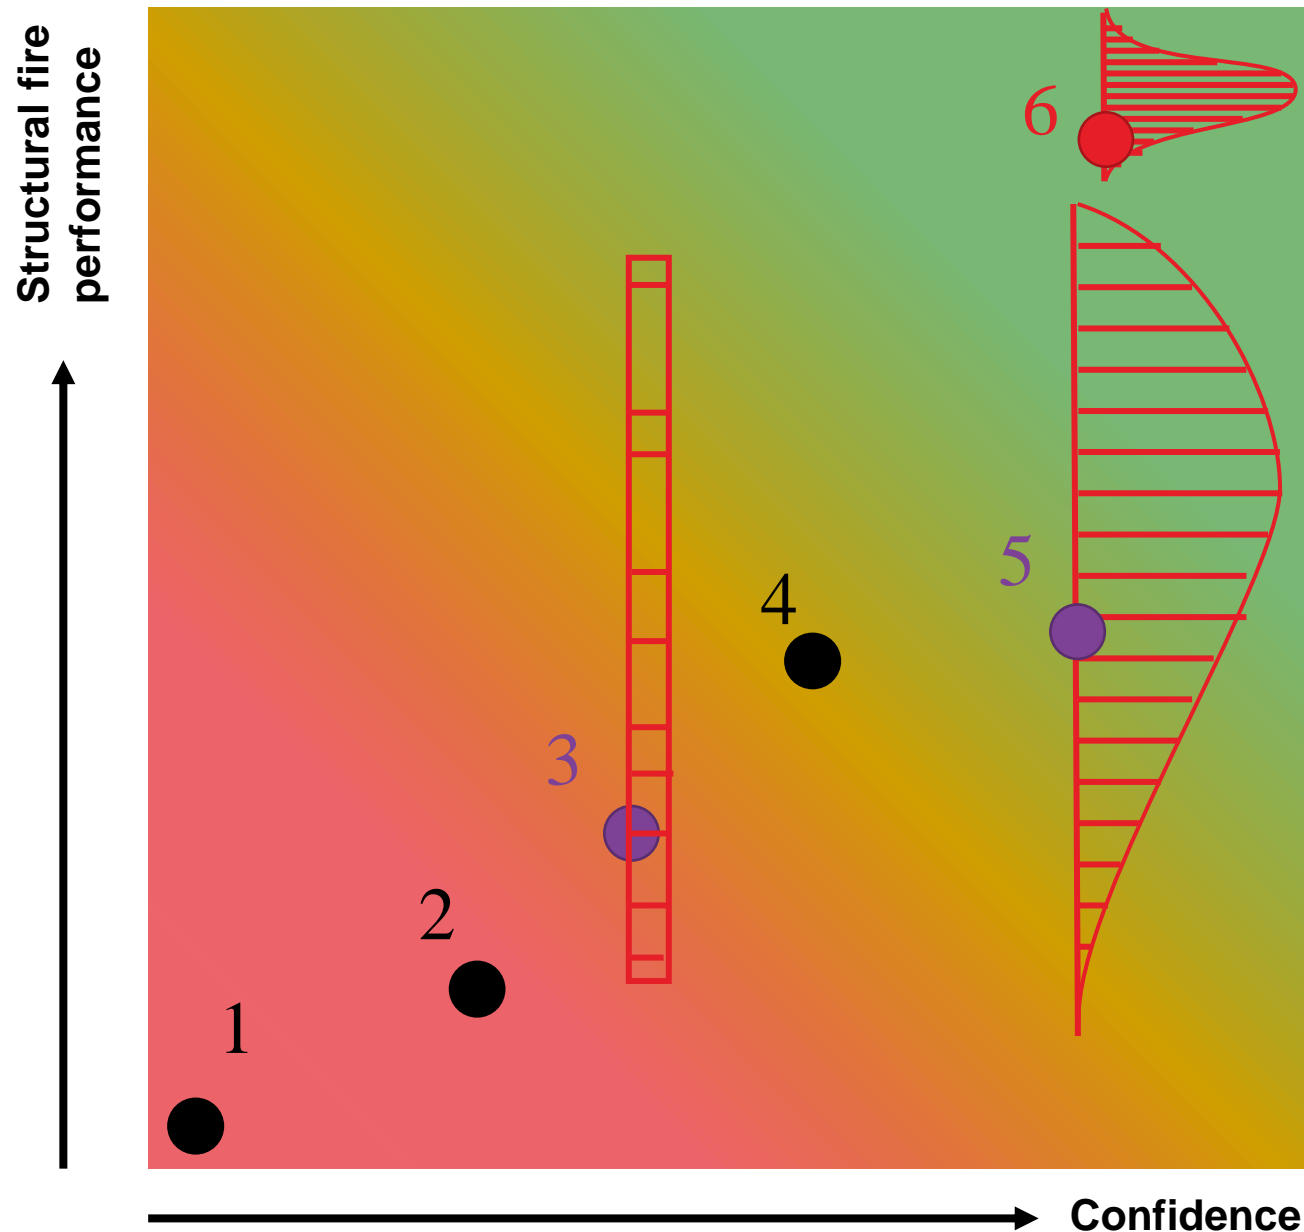
1. Understanding – identify floor type
2. Understanding – pilot survey
3. Assessing – assessment of survey data
4. Understanding – full building survey
5. Assessing – assessment of survey data
6. Evidencing – full remediation

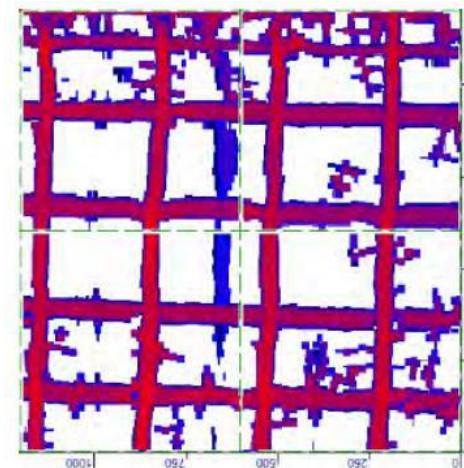
Ferroscan image showing slab soffit reinforcement arrangement.

N/S bars with spacing 200-300
Estimated minimum cover – 24mm (including finishes)

E/W bars spacing 300
Estimated minimum cover – 15mm (including finishes)
Estimated bar size – 12-14mm

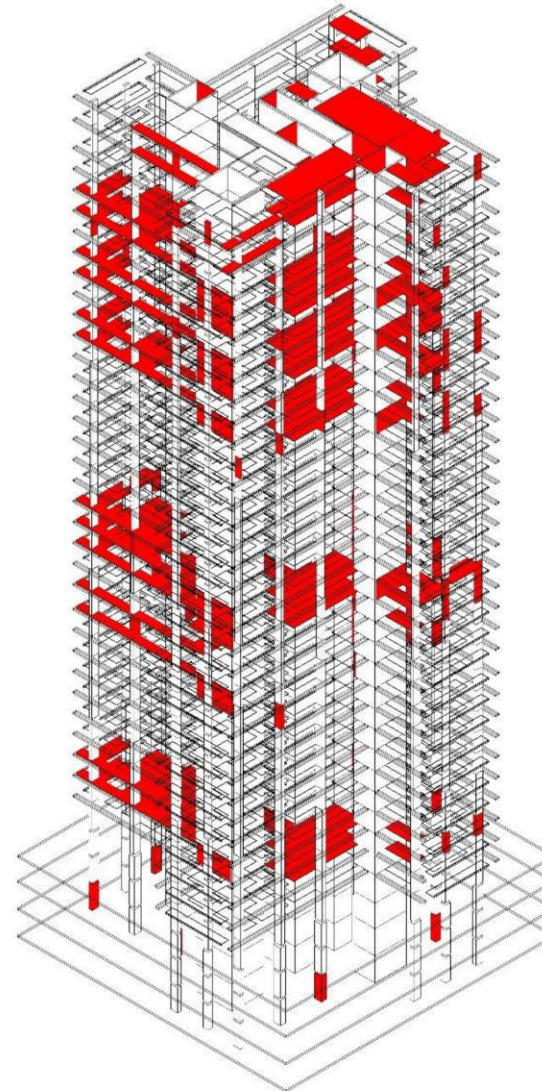
Figure 2: Arup Revit model showing which structural elements were measured by Sandberg's covermeter (RED = elements with survey data (scanned or measured), typically one reading per member)
